Contrasting Access Mats and Conventional Powerline Construction Impacts on Mixedgrass Vegetation

Faezeh Najafi¹, Edward W. Bork¹, Cameron N. Carlyle¹, Sylvie A. Quideau², Kassia James¹

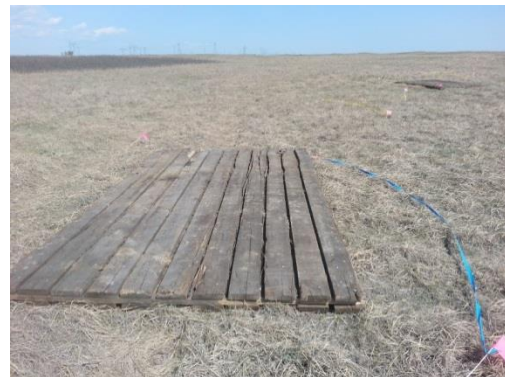
Figure 1. Low disturbance site where access rig mats are in place for up to 4 months.

This study was conducted at 15 high voltage tower sites associated with the ATCO Eastern Alberta Transmission line crossing the University of Alberta's Mattheis Research Ranch, 40 km north of Brooks, Alberta, Canada. The powerline was constructed between September 2013 and September 2014. Sites range from Orthic Brown Chernozems that are dominated by *Hesperostipa comata* on loamy prairie to Rego Chernozems on sandy soils that are dominated by *Calamovilfa longifolia*. Towers were divided into those constructed with either low disturbance (LD; n=8) in which access mats were in place for up to 4 months during construction and vegetation was allowed to recover naturally (Fig. 1), or high disturbance (HD; n=7) in which soil was stripped, piled, and replaced 8 months later, and hydro-seeded in October 2014 (Fig. 2).

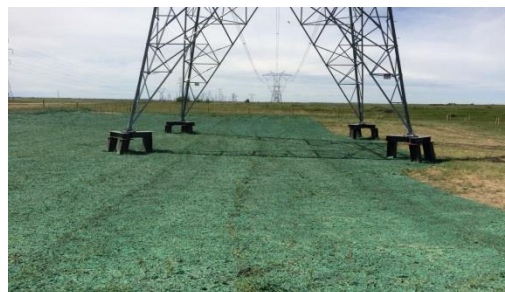
Figure 2. High disturbance site where soil is stripped, piled, and replaced up to 8 months later and reseeded.

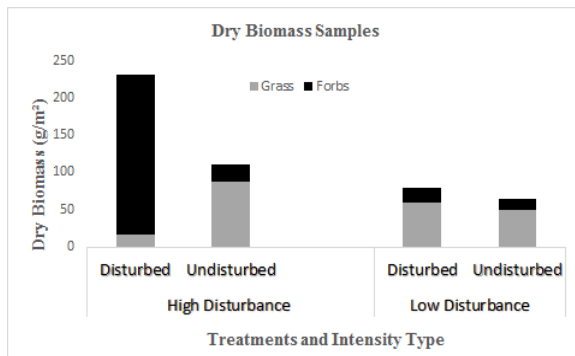
Figure 3. Biomass of grass and forbs in communities receiving different levels of industrial disturbance.

High disturbance sites were colonized by forbs leading to an increase in biomass even though grasses almost disappeared from the site (Fig. 3).

Grass biomass was higher in LD sites where a seed mix was added. It should be noted that control sites were markedly different from each other, possibly indicating a procedural bias in where tower installation methods were used (Fig. 3). Low and high disturbance sites also differed markedly in their cover of litter (HD 0%, LD 82%; P-value < 0.001) and microphytic crusts (HD 0%, LD 12%, P-value 0.05) which were completely lost when the site was stripped, which could have consequences for the long term function and recovery of these sites.
